BP GoM Multi-Field Riserless Intervention Campaign – Mechanical and Hydraulic

OWI MED September 20, 2022

Matthew Vick BP Senior Subsea Wells Engineer

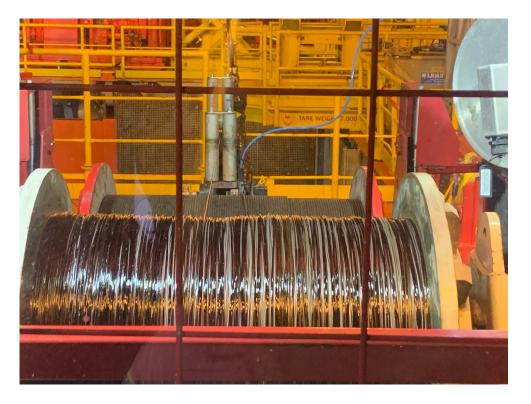
- Slickline became stuck in the pressure control head due to asphaltene build up on the wire during a deep drift run
- Circulated xylene into lubricator below pressure control head to help dissolve asphaltene blockage
 - Successfully remediated and POOH
 - Required full redress of well control package rubbers (ram and PCH) after well due to material compatibility issues
 - Collapsed circulation hose due to subambient conditions
- Lengthened xylene soaks and flowback to start interventions on at-risk wells

Asphaltenes deposited on slickline

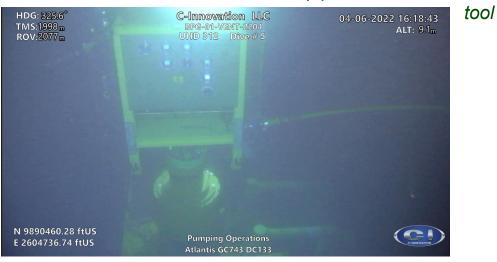
Collapsed circulation flying lead

- Collapsed coil tubing hose jumpers (two wells) due to low wellbore pressure while bullheading stimulations
 - No leaks or loss of containment during operations
- Collapsed circulation flying lead (one well) when circulating xylene to remediate stuck wire
 - Multiple pinhole leaks found subsea when pressuring up after xylene soak
- High collapse flexible pipe successfully implemented as hose jumpers for stimulations on lower pressure wells
 - Alternative HCR hose jumpers also being developed

High collapse flexible pipe connected to stim

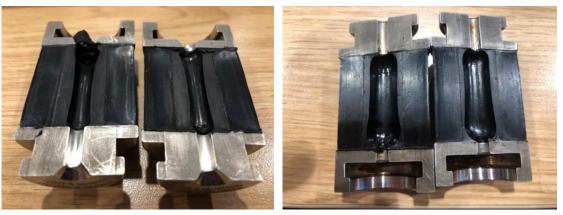
- While RIH with R-Lock on slickline, diesel was observed leaking past the upper packoff on PCH.
- Unable to regain seal on upper packoff, emergency packoffs engaged to stop leak and POOH
- Packoffs inspected on deck with visual wear/damage, replaced
- Re-ran R-lock, no leaks, packoffs inspected after run also showed damage/wear
- Finished well utilizing grease/flowtubes to provide seal on slickline as well as packoffs, no further packoff damage seen
- Findings:
 - Grease appeared to lubricate packoff rubbers reducing wear due to diesel
 - Excessive packoff pressure being applied

Packoff damage when RIH with diesel in bore

No packoff damage seen when also using grease with diesel in bore

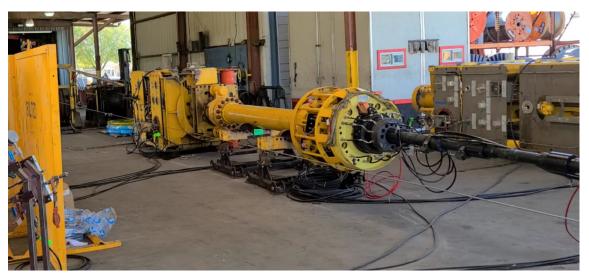
Dynamic testing of PCH with wireline

- While RIH and POOH during production logging operations on high pressure well (~9,000 psi SITP), experienced multiple losses of grease seal
- Performed investigation with contributing causes determined:
 - Insufficient grease supply
 - Grease contamination
 - Unreliable grease regulators
- Revised PCH and surface grease supply system between wells:
 - New grease regulators
 - Revised flowtube/injection stackup
 - Additional check valves, gauges, flow meters
 - Performed full scale dynamic testing to qualify new grease control system

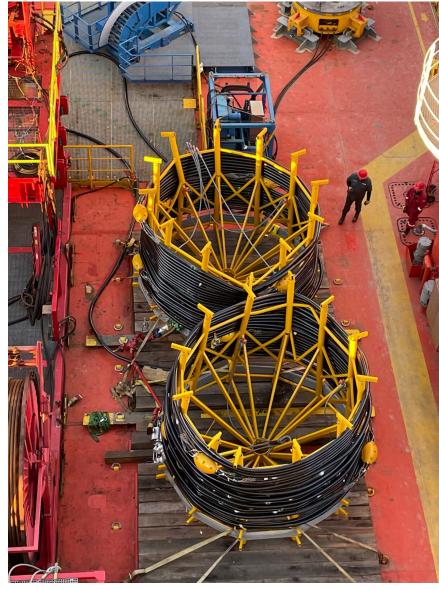
Collapsed carousels
