DOWNHOLE POWER TOOL (DHPT) - UNCONVENTIONAL FISHING

Upgrade your pulling capacity - Over 230k lbs applied down hole to free, with 44 strokes required to recover

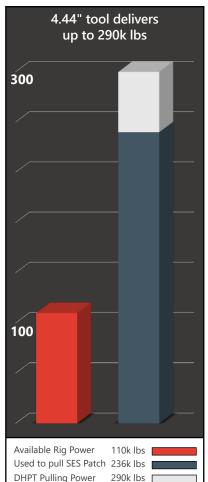
Annulus pressure on the well caused the Stainless Expandable Seamless (SES) casing patch to collapse, closing off access to the well and allowing communication behind the 5 1/2" casing.

Collapsed 5 1/2" SES casing patch recovered with DHPT

Ardyne's 4.44" DHPT was run in hole, screwed into fish and worked for two hours between 3,500 – 6,500 psi, equivalent to 127,085 – 236,015 lbs of pulling force. After working various pressures for two hours, the fish broke free and began to move. All reactionary forces were contained down hole due to the DHPT.

When attempting to pull out of the hole, the casing patch became wedged on the next 1,760' of casing collar connections, requiring repeated activation of the DHPT. After 44 activations, the rig was able to pull the casing patch without assistance from the DHPT.
