Well
Intervention Workshop
MED
20 September 2022

Preserving and Restoring Structural Integrity of Conductors & Well Casings

Bruce Trader
MADCON Corporation

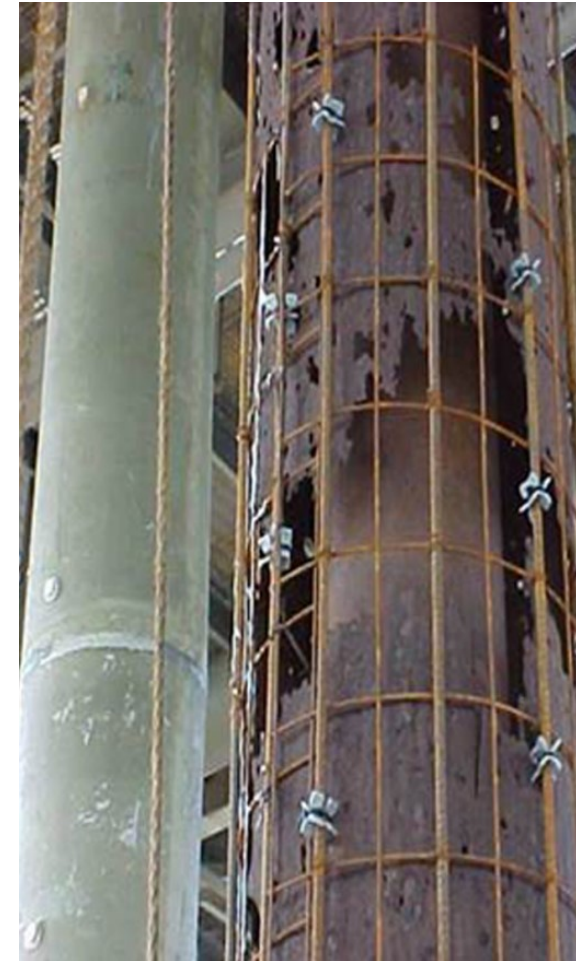
After several years of production and less than optimal maintenance, the company had numerous conductors that had severe corrosion and required an immediate solution.

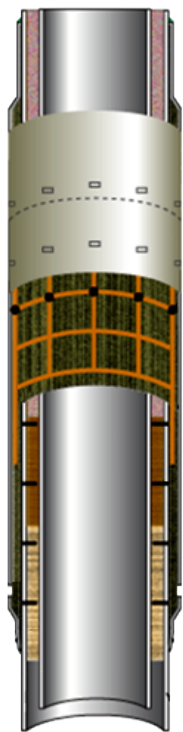
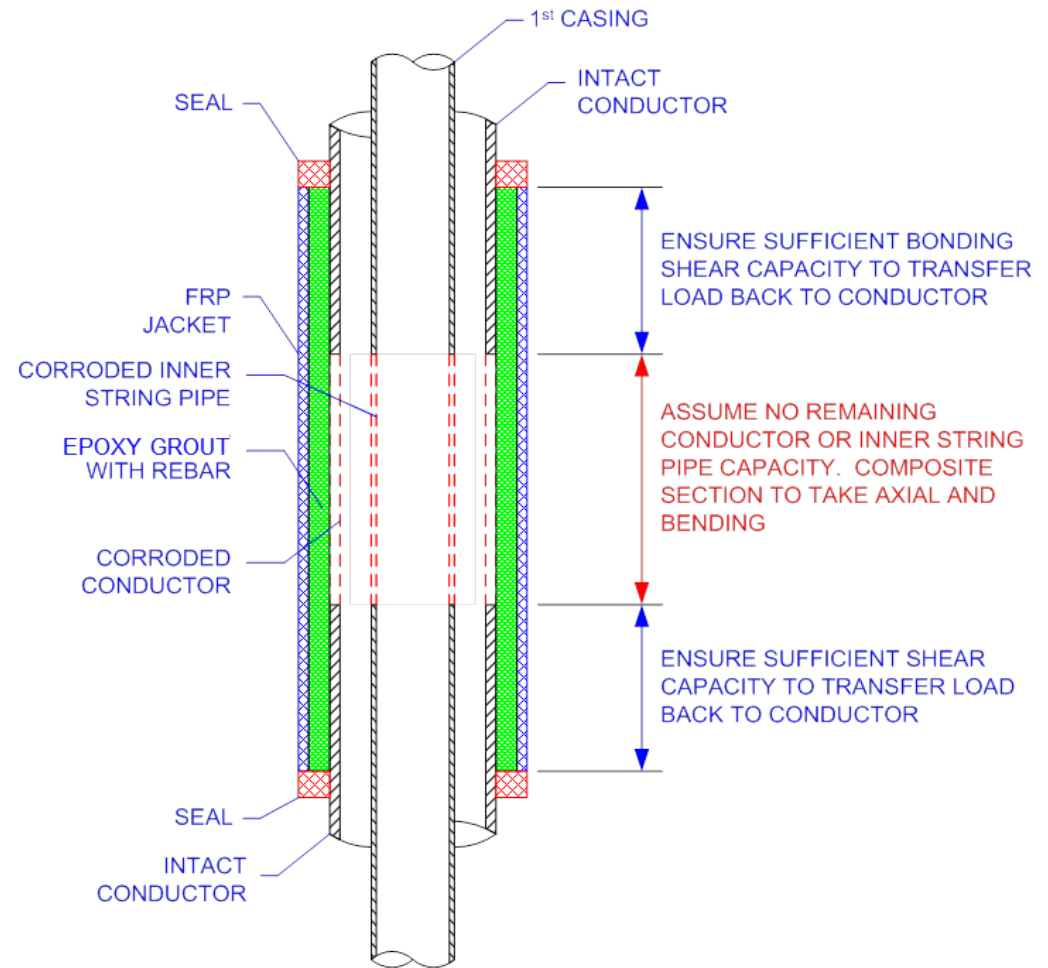
- Engineering analysis
- Restore original design capacity

Repaired Capacity

• 780 kips or greater
(3,470 kN) axial

• 8,196 kips-in (926
kNm) bending

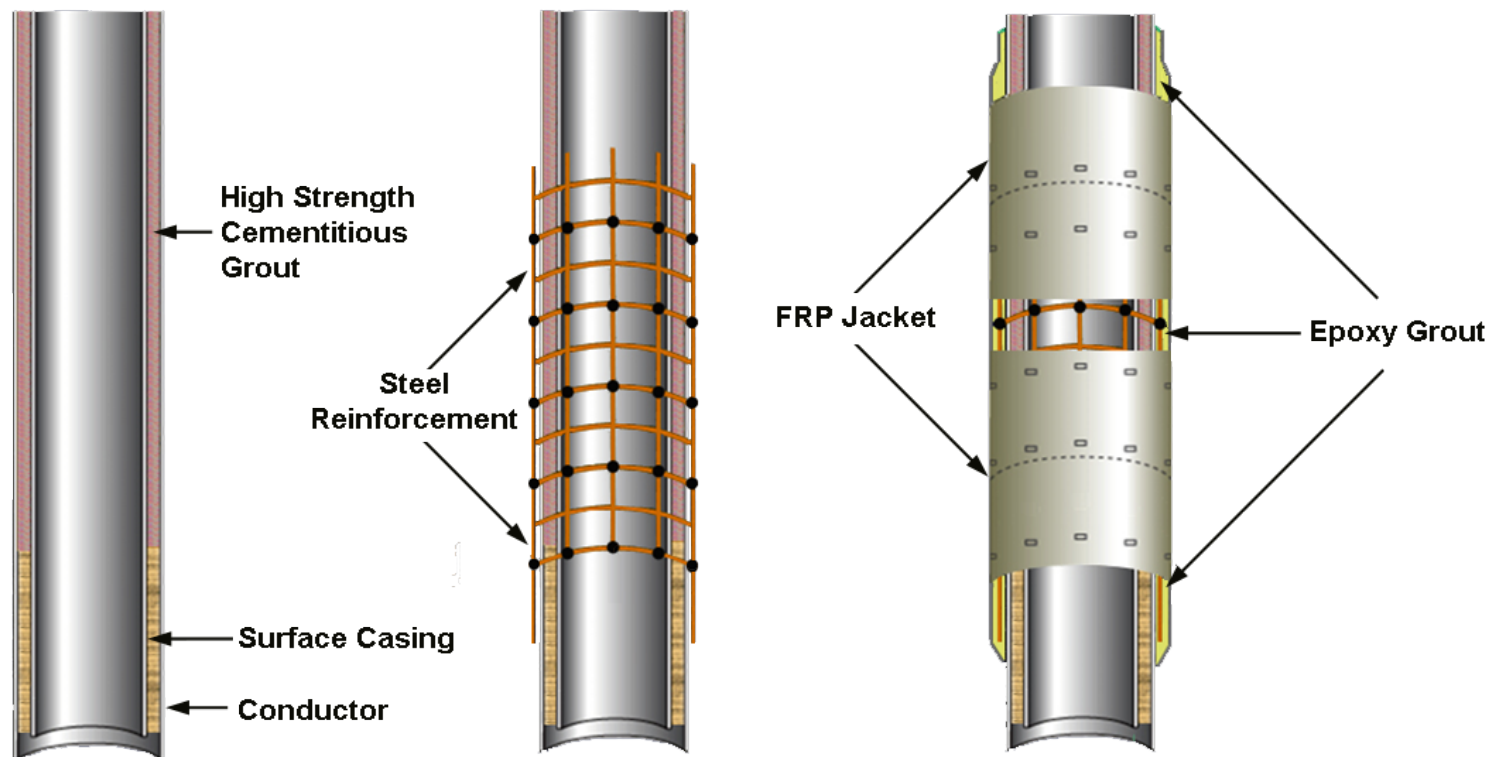
- Precision Cementitious Grouting- Surface Casing to Conductor
- Precision Epoxy Grouting- Conductor to FRP Jacket

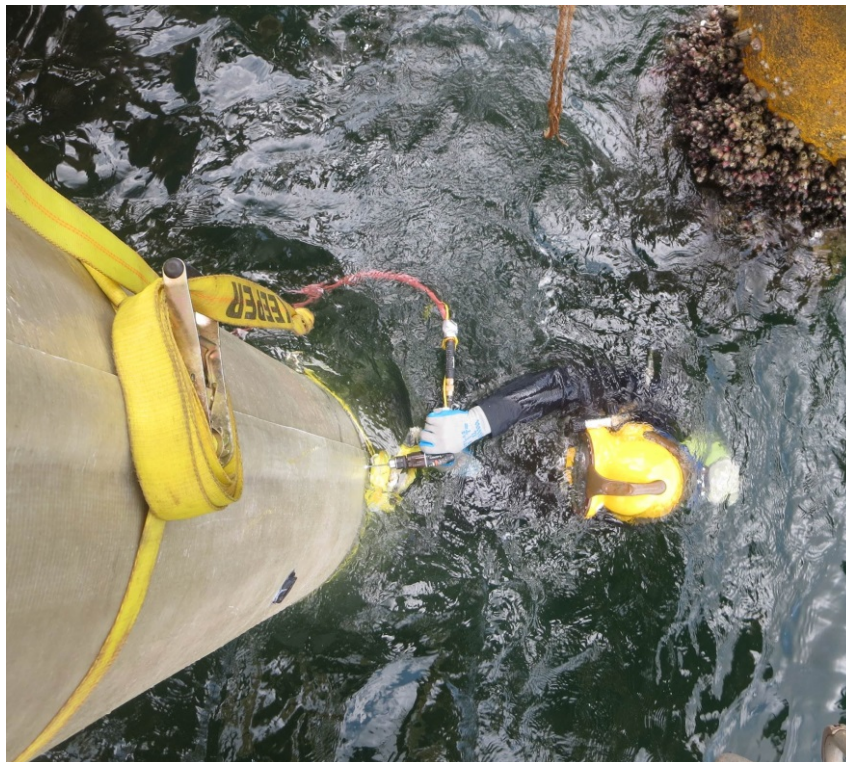
- Lightweight materials - composites
- Easily installed in splash zone

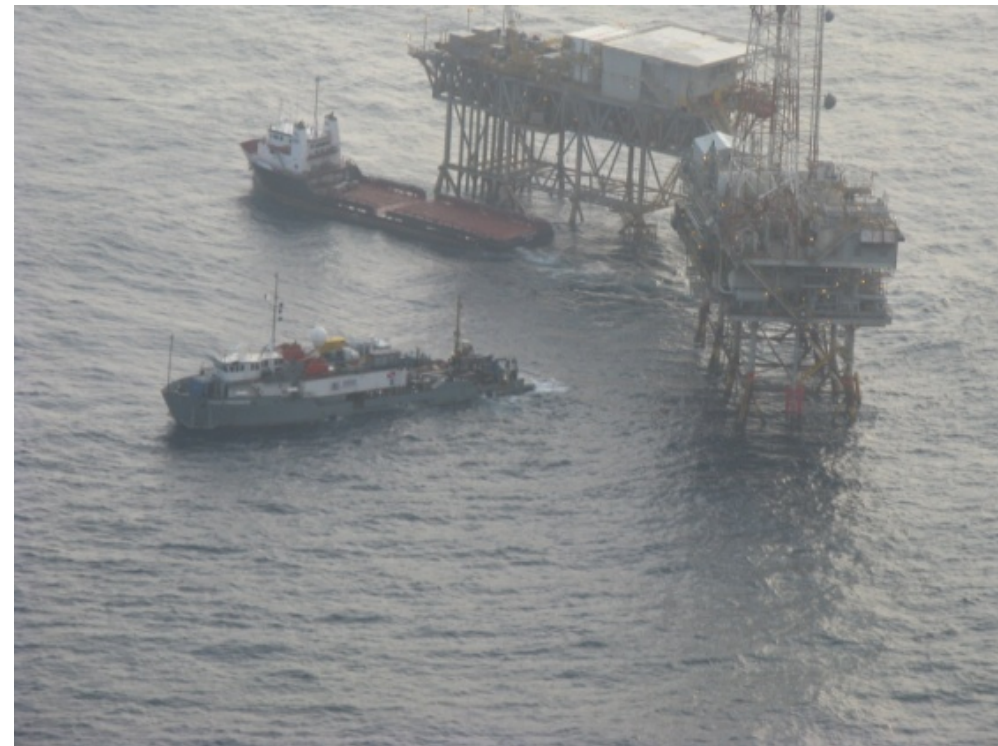
- Work from vessels or the platform
- Does not require barge or rig

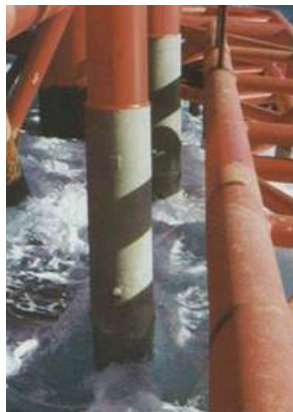
- Long term corrosion protection
- Eliminate future maintenance

May 1994
(Initial Installation)

October 2016
(22 Years After Installation)
Now 27 years & counting.

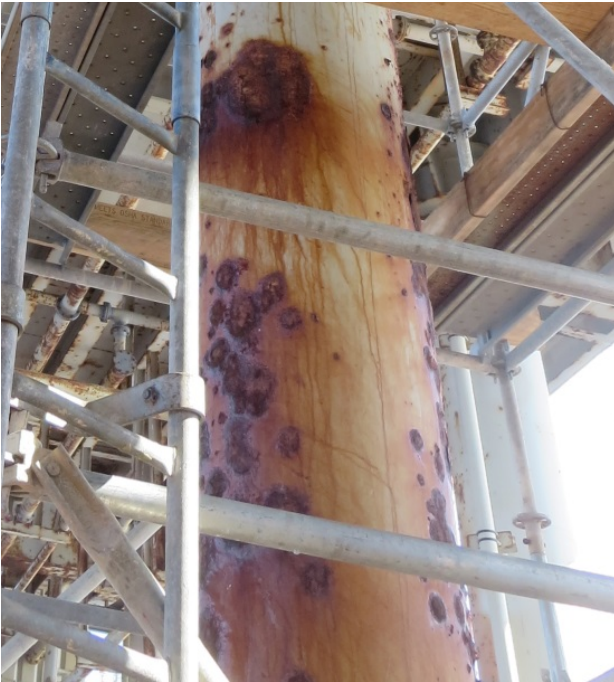
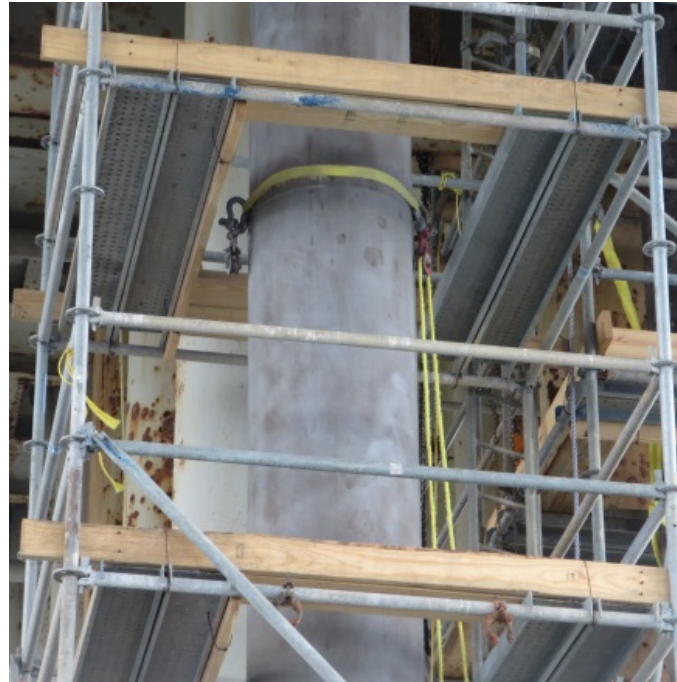
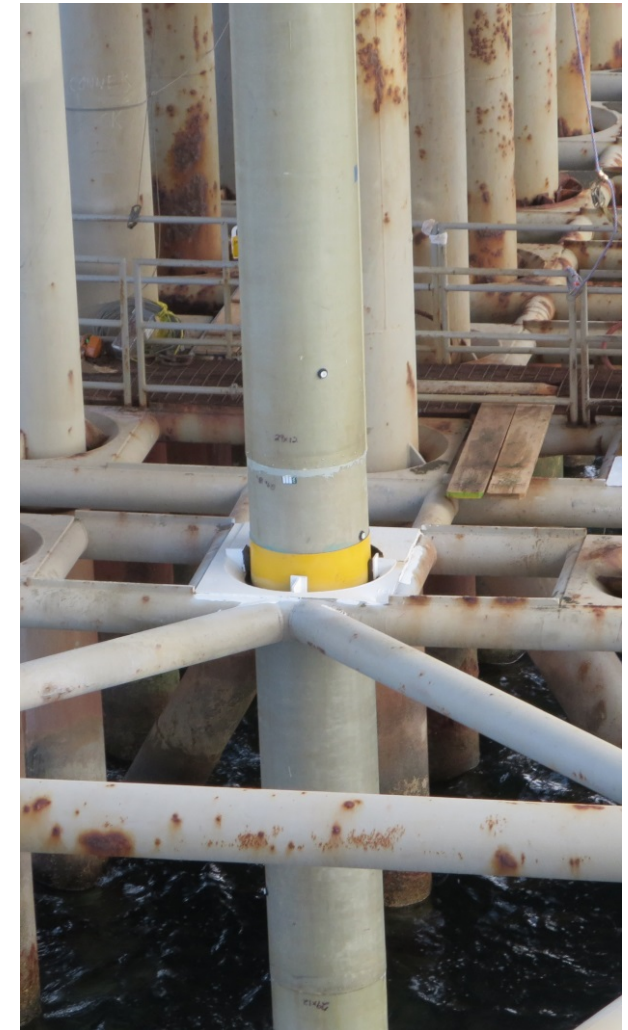
- Operator planned sidetrack
- Heavy external corrosion / wall loss.
- Work performed from platform.
- Total repair 23 meters. (-)3 to (+)20 well head.
- Full structural restoration plus long term corrosion protection.
- Project duration 5 days utilizing 8-man crew.

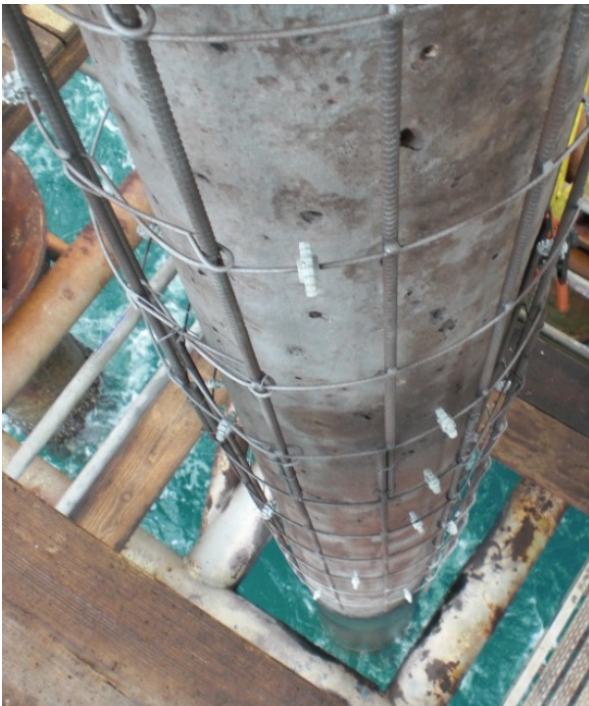
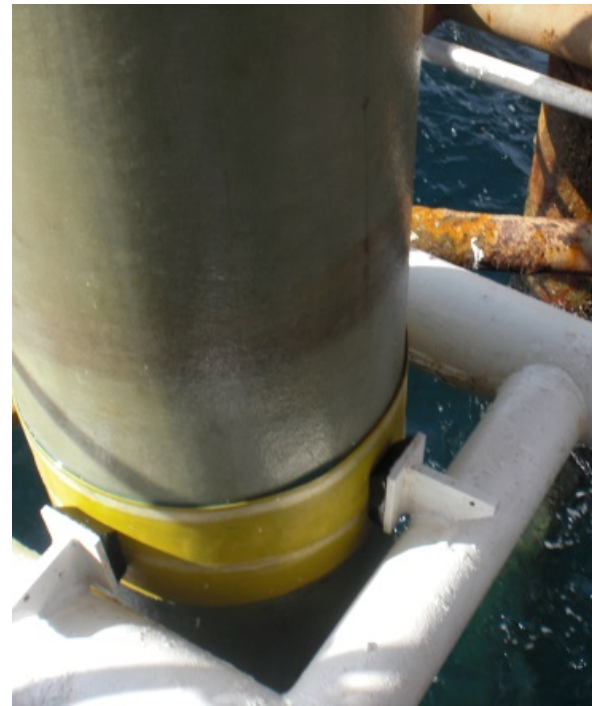
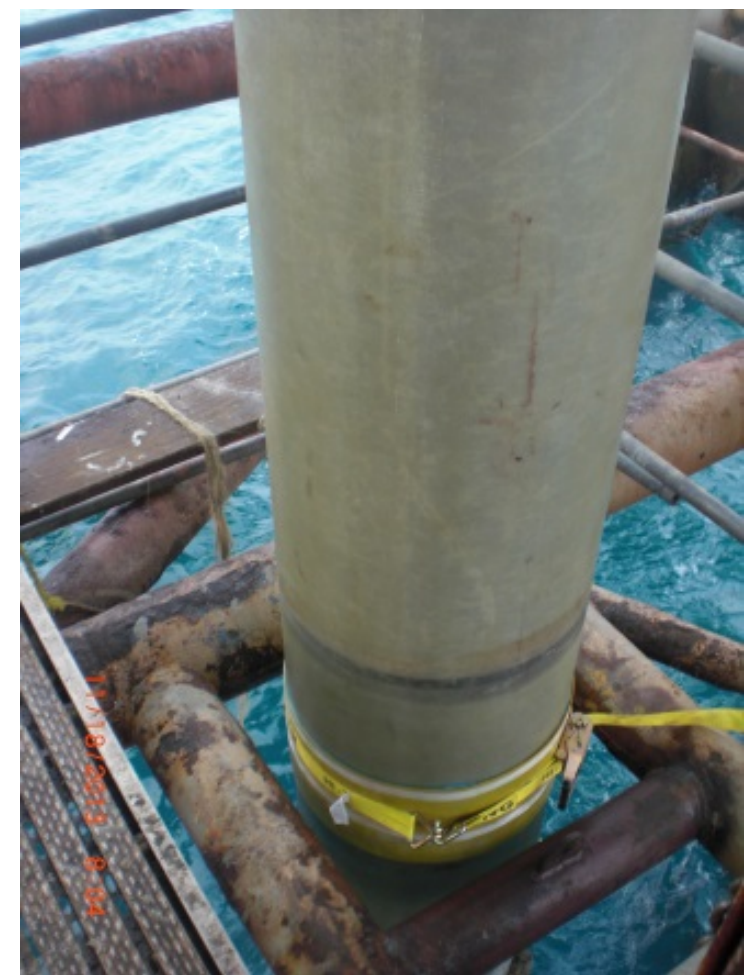
- Heavy external corrosion / wall loss / perforations.
- Work performed from platform.
- Total repair 23 meters. (-)3 to (+)20 well head.
- Full structural restoration plus long term corrosion protection.
- Project duration 9 days utilizing 8-man crew.

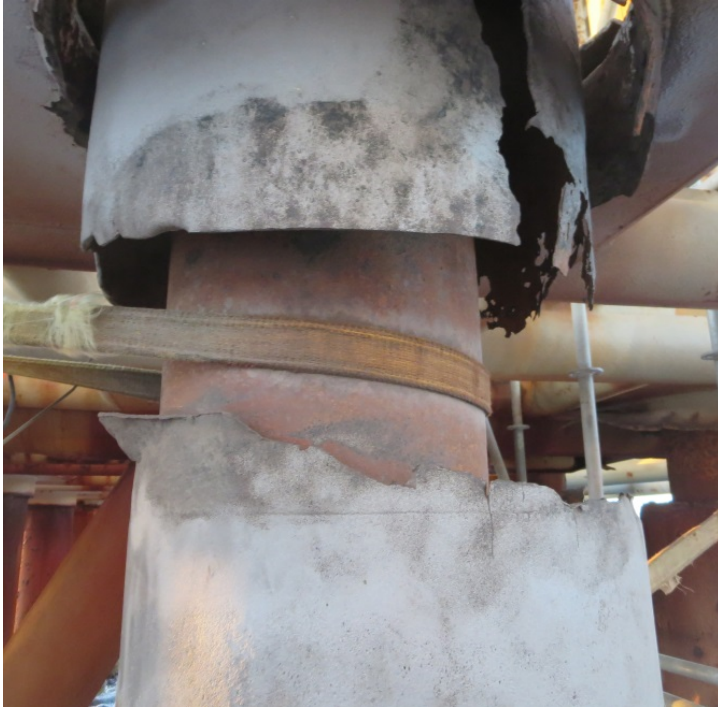
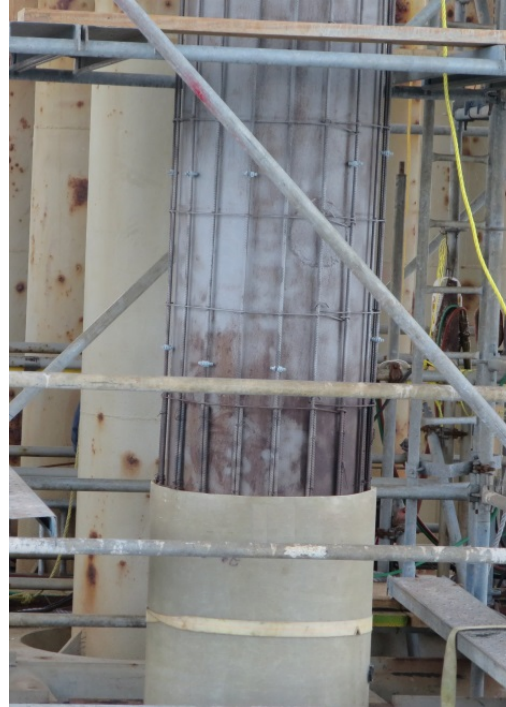
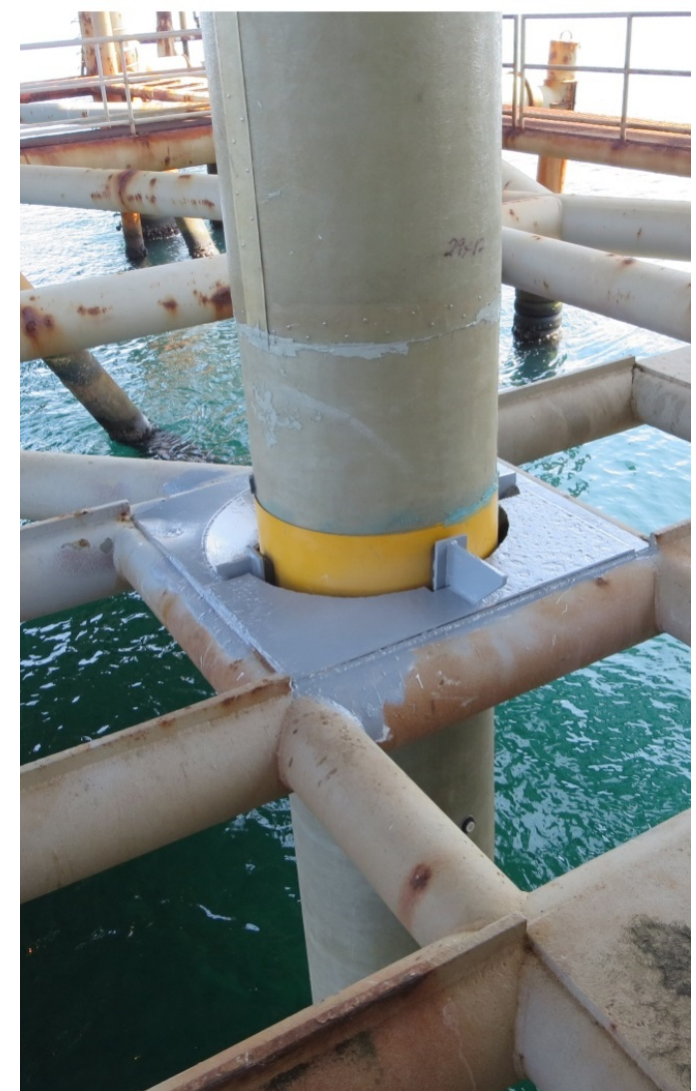
- Parted Conductor.
- Work performed from platform.
- Total repair 23 meters. (-)3 to (+)20 well head.
- Full structural restoration plus long term corrosion protection.
- Project duration 10 days utilizing 8-man crew.

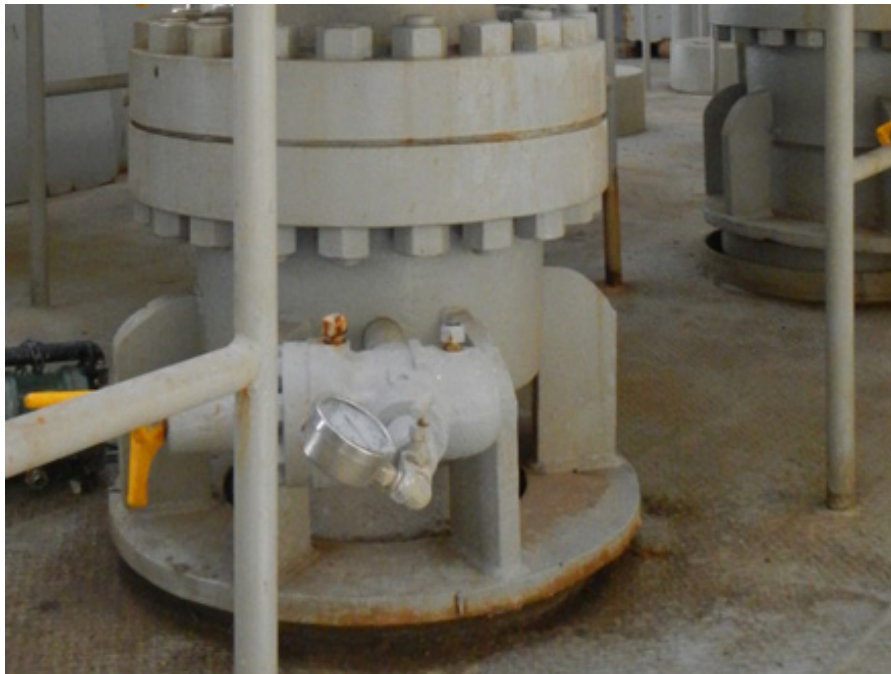
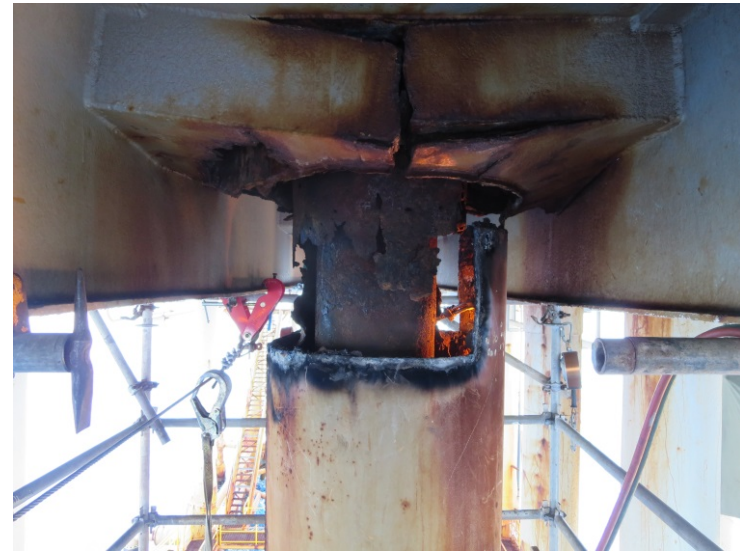
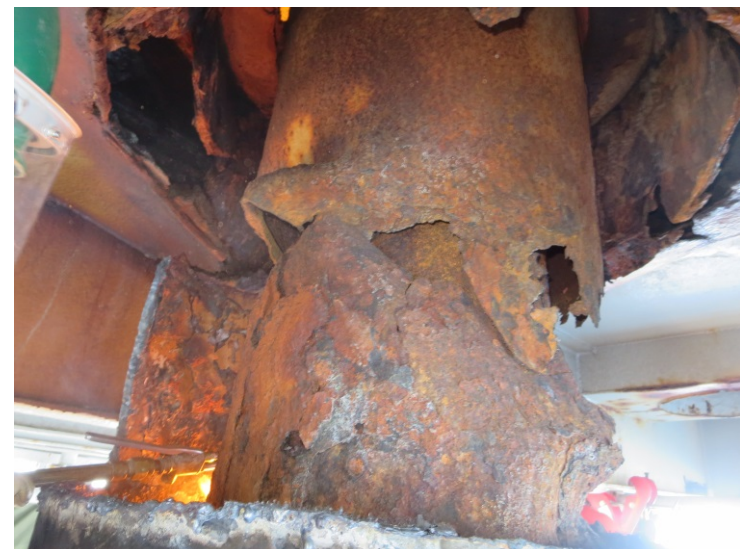
- Collapsed Well.
- Prior inspections reported no abnormal operating conditions.
- MADCON inspection identified well had collapsed.

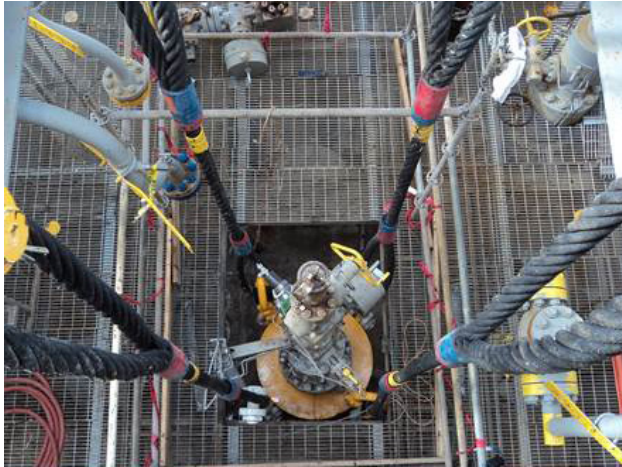
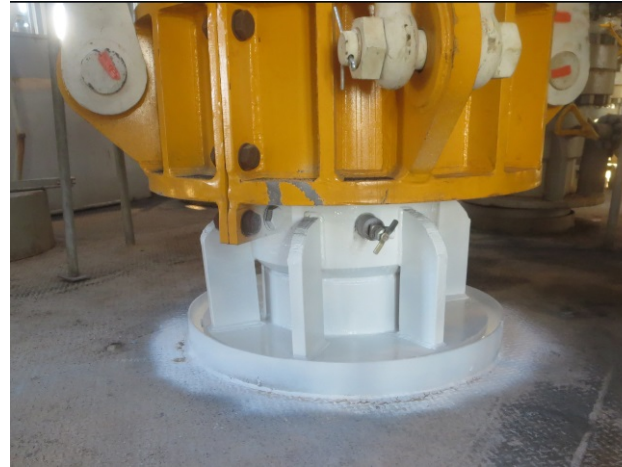
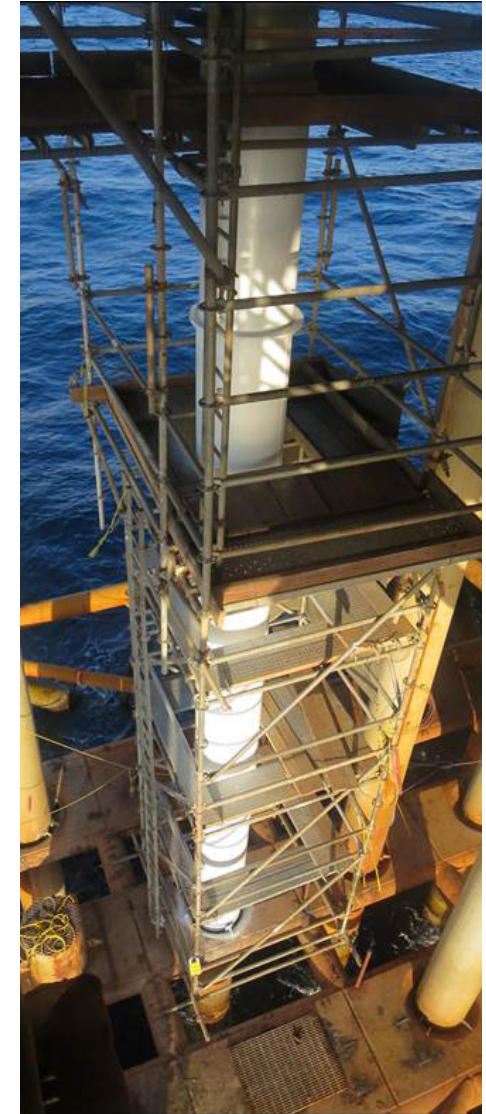
- Designed / Engineered lifting mechanism that did not require rig or barge.
- Total repair 23 meters. (-)3 to (+)20 well head.
- Full structural restoration.
- Project duration 12 days utilizing 8-man crew.

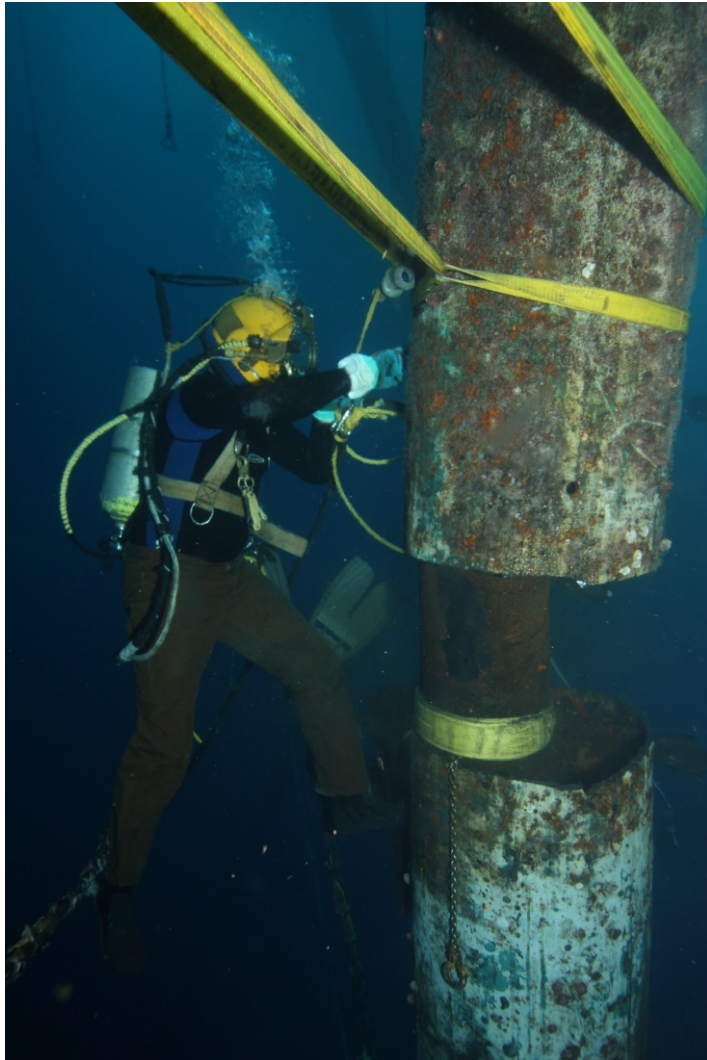
- Sub Sea Parted Conductor.
- Grouted Conductor to SC Annulus.
- MADCON Structural Bonded Clamp.
- (-)25 to (-)20 meters.
- Full structural restoration.
- Project duration 11 days utilizing 8-man crew.

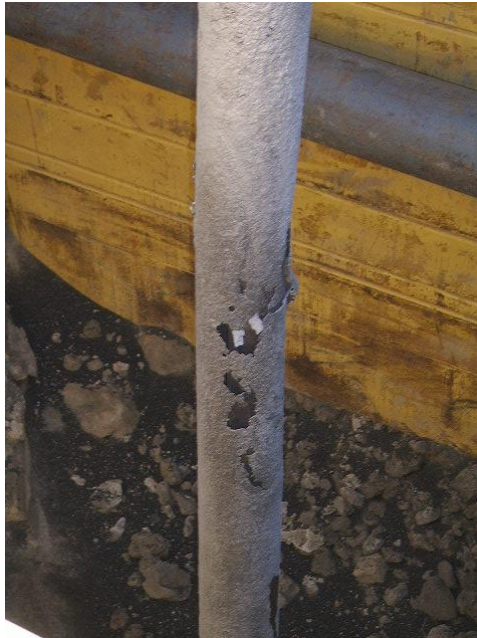
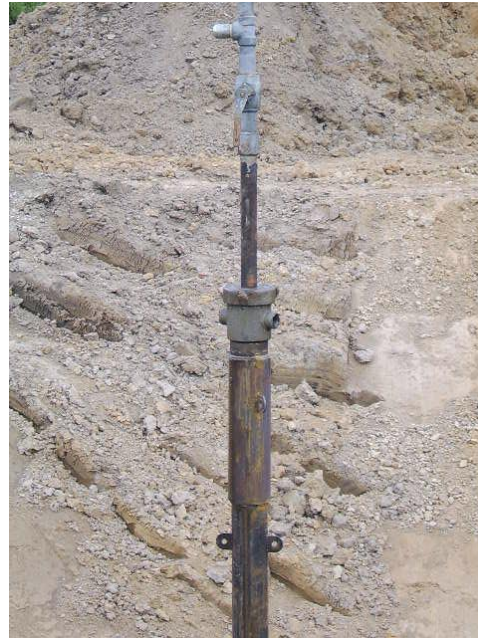
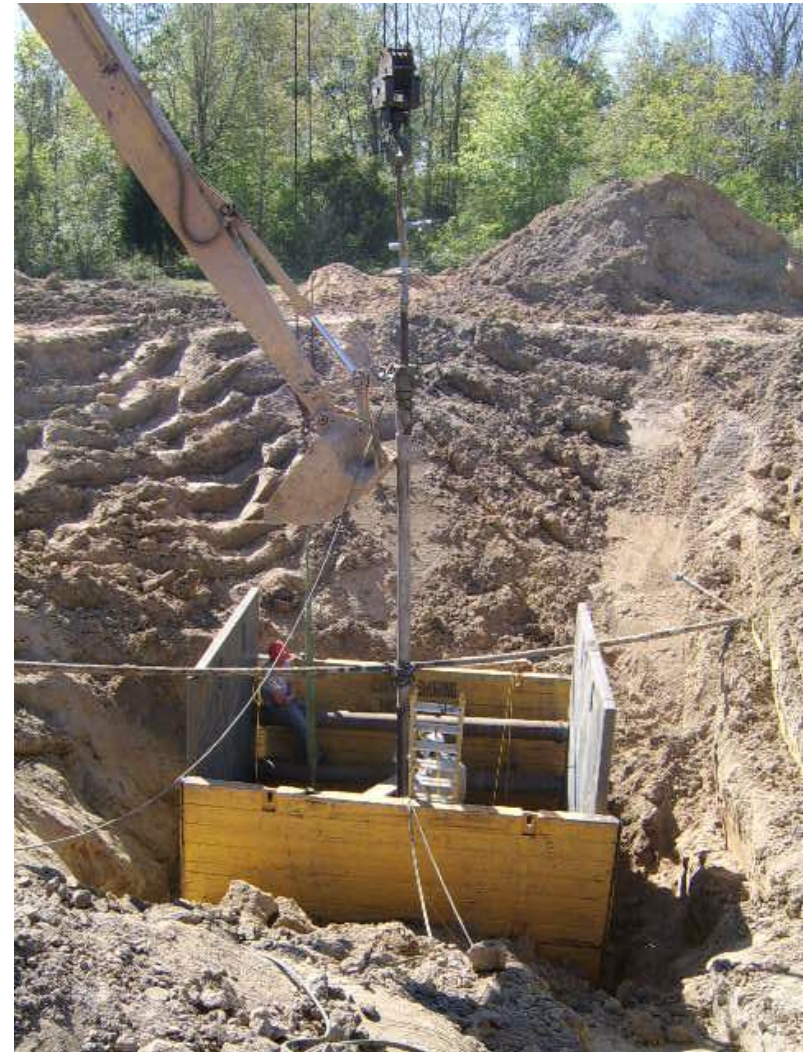
- Land Based Collapsed Well.
- Hidden corrosion just below ground interface.
- MADCON Structural Bonded Clamp.
- Full structural restoration.
- Project duration 2 days with 4-man crew

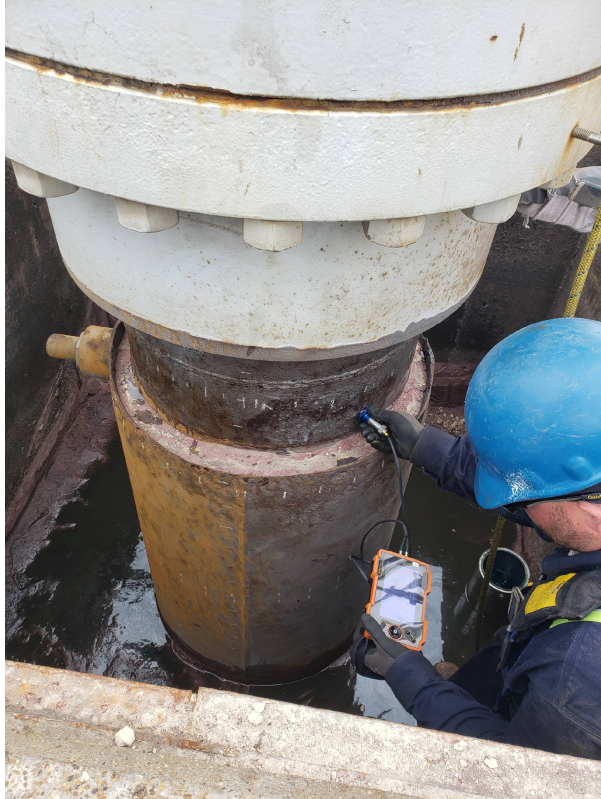
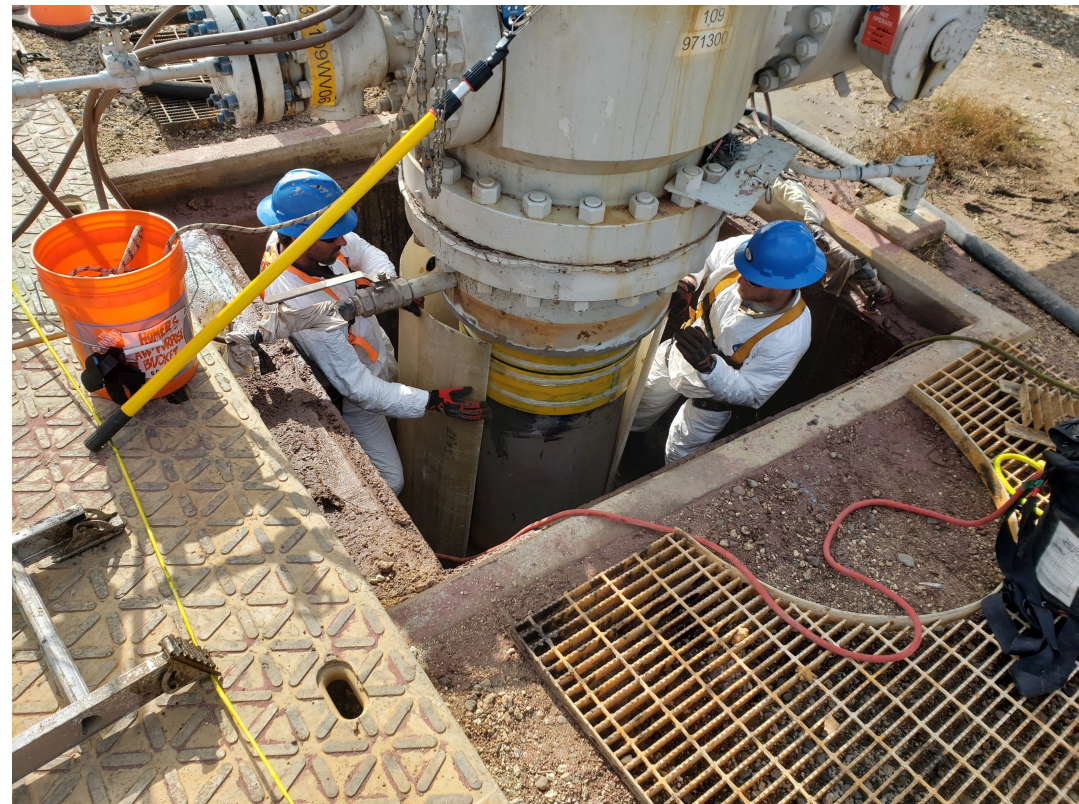
- Five Year Maintenance & Repair Contract.
- Land Based Wells for U.S. Strategic Petroleum Reserve (Operator: Fluor Federal Petroleum Operations)
- Exposed Casing In Concrete Sump Creates Hot Spot For Corrosion.
- MADCON SCR Process For Corrosion Protection And Casing Reinforcement.

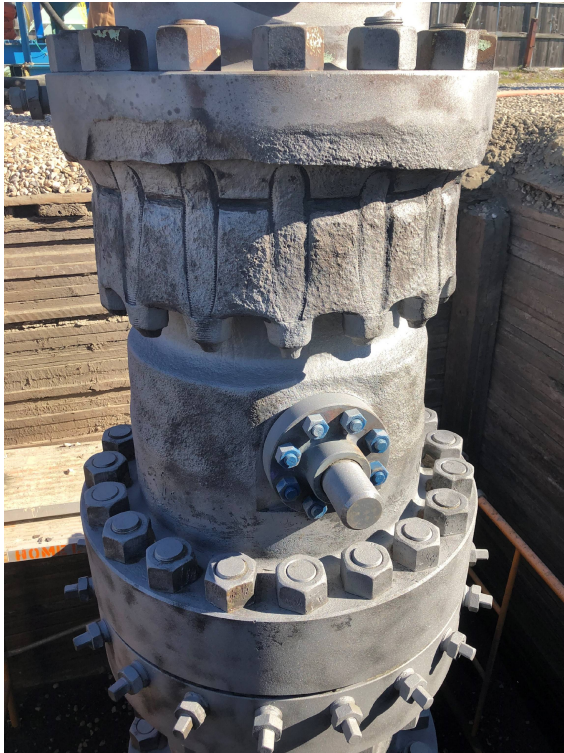
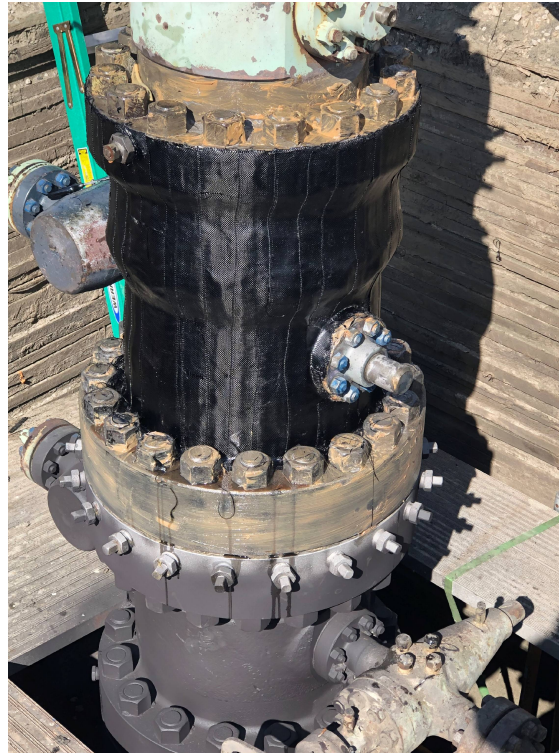
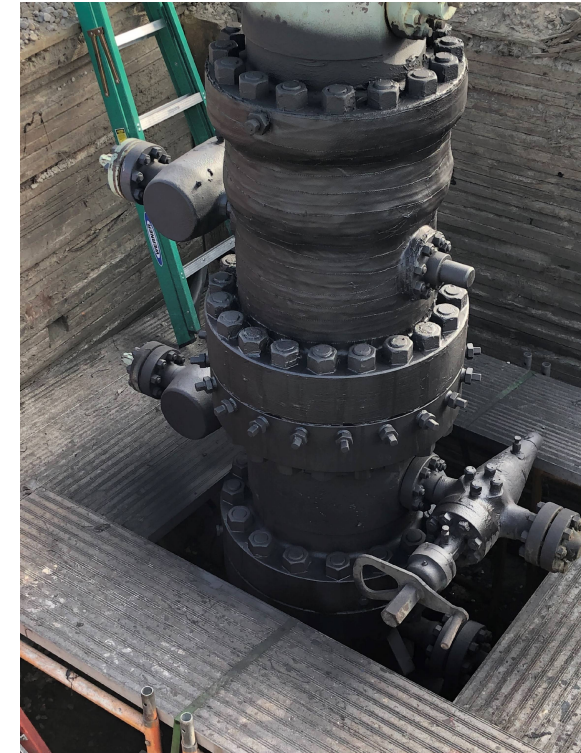
- When operator excavated to perform maintenance on valves; extreme corrosion was discovered.
- Due diligence emergency strengthening of high temperature well.
- Four-man crew; 3 days on site. Total cost: \$100,000 USD
- Immediate cost savings to customer: \$750,000 USD

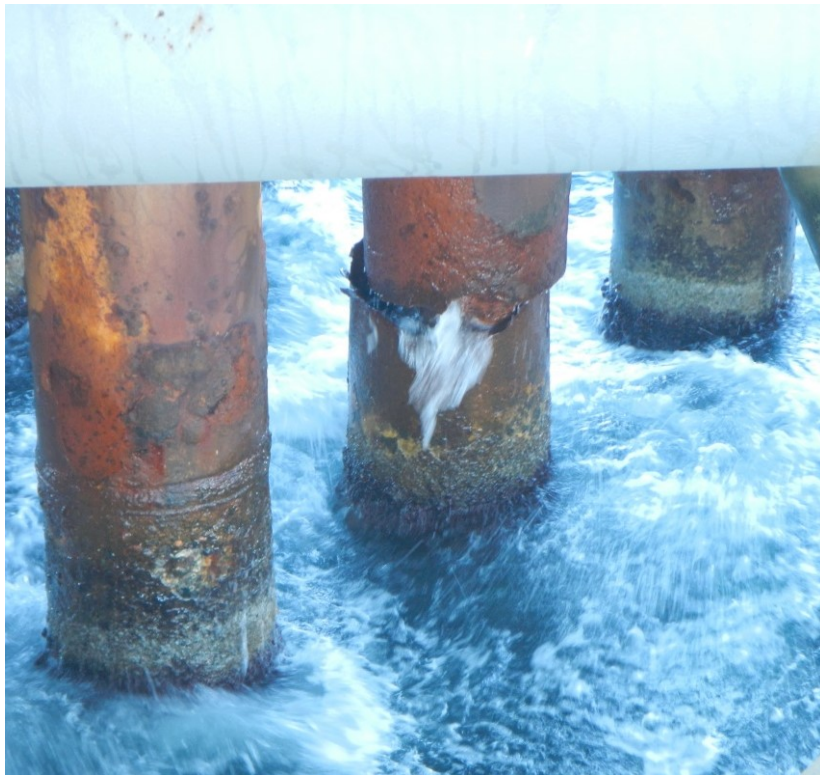
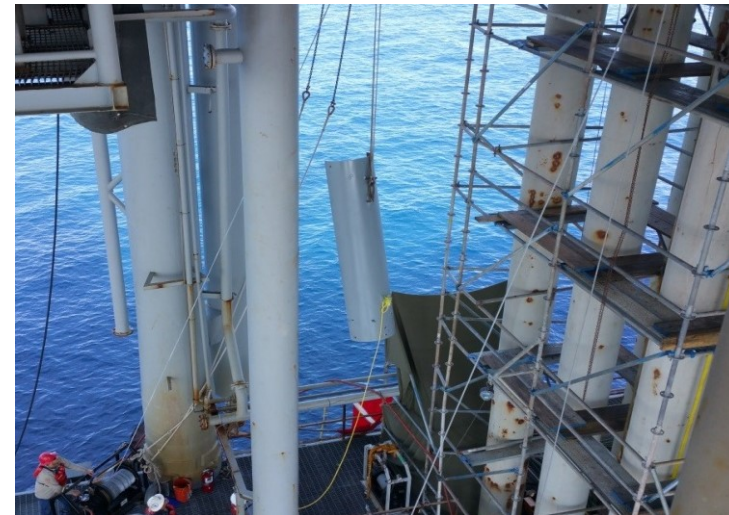
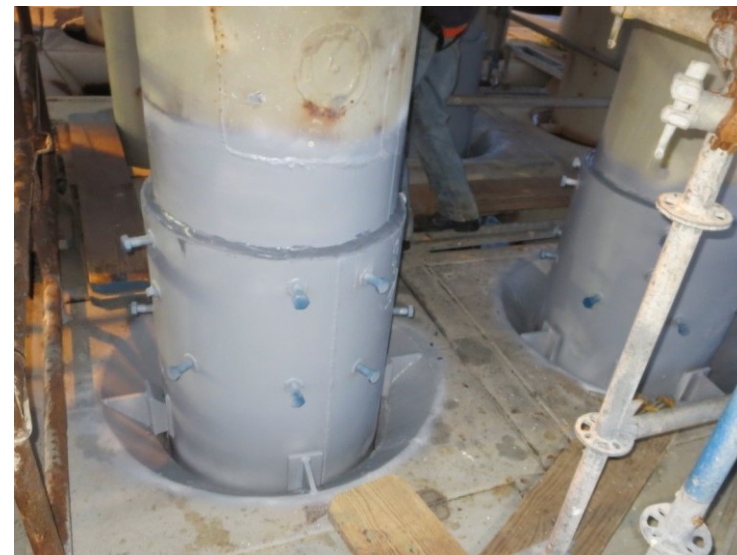
- Parted Conductor.
- Grouted Conductor to SC Annulus.
- MADCON SCR Process Type 4 Bonded Sleeve Employed for Structural Repair

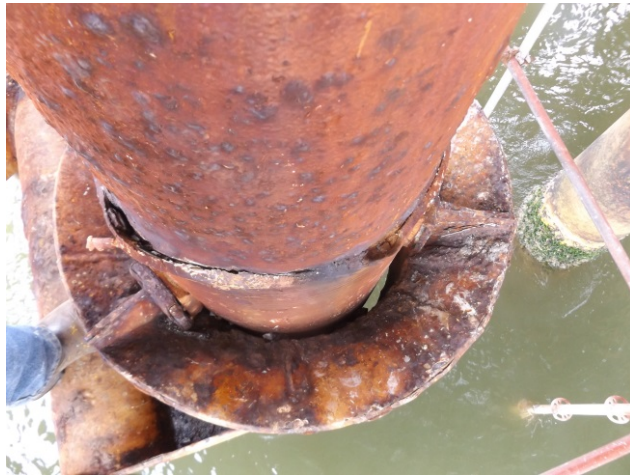
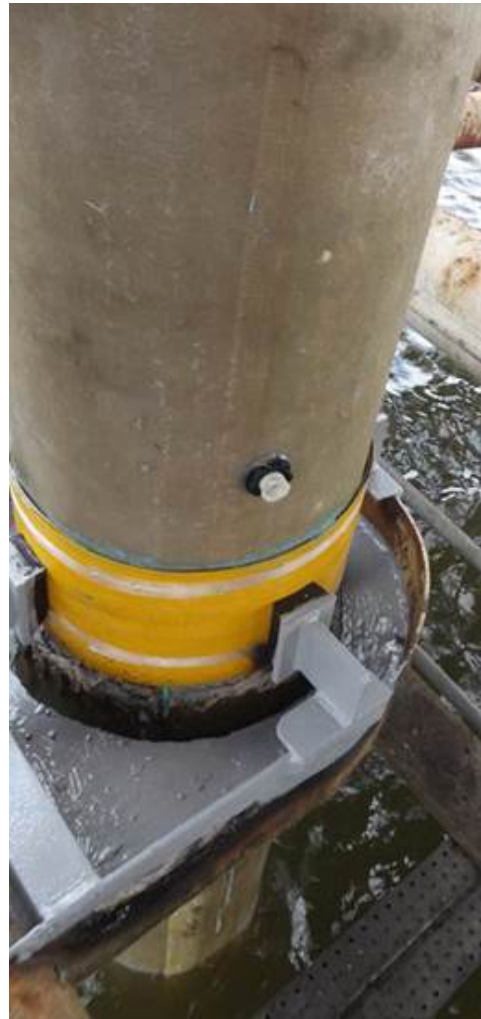
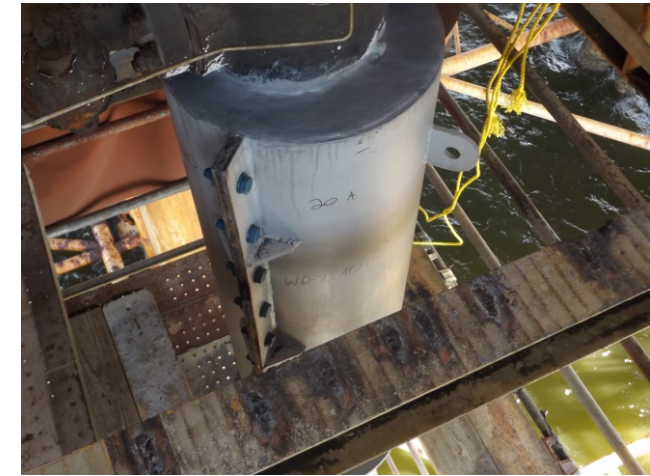
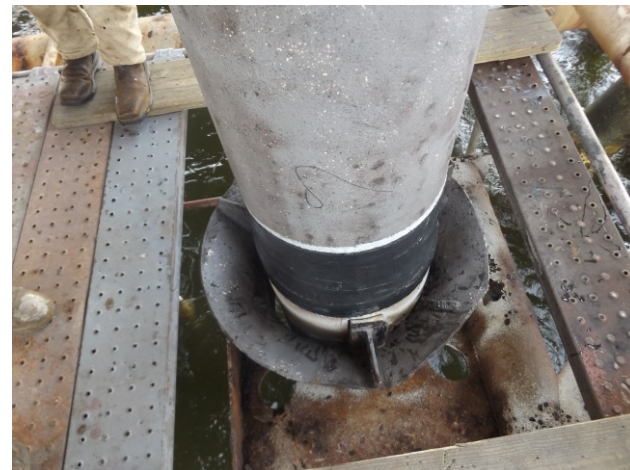
- Parted Conductors.
- MADCON SCR Process Type 4 Bonded Sleeve Employed for Structural Repair

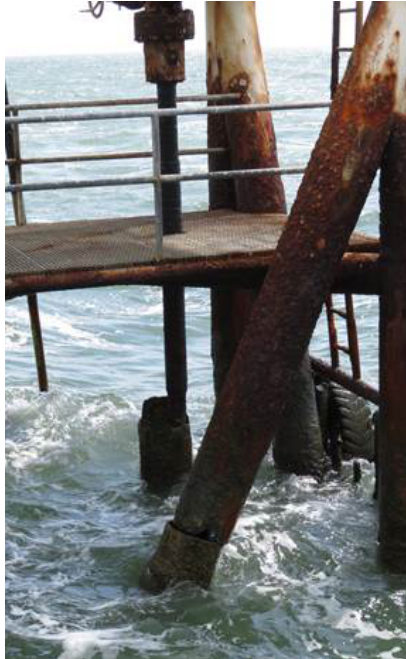
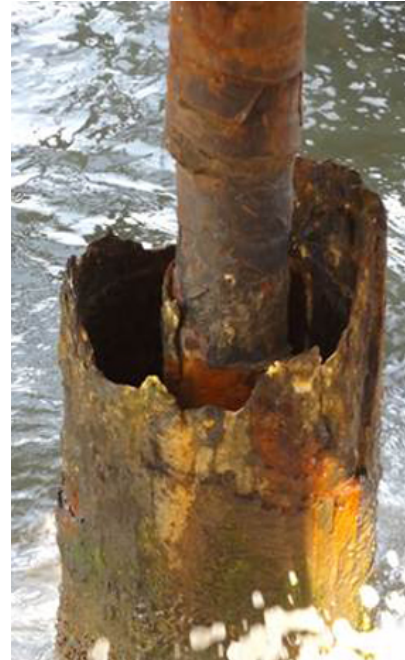
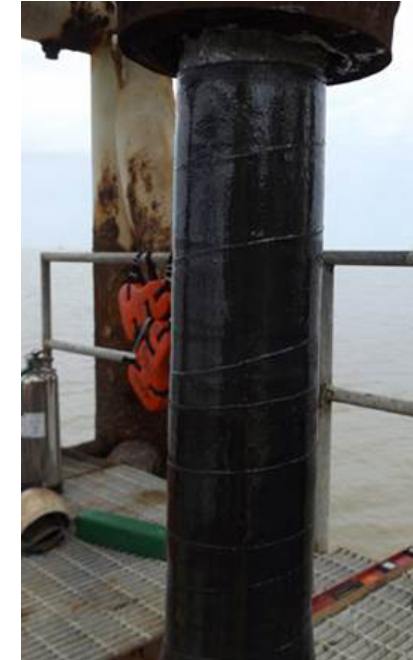
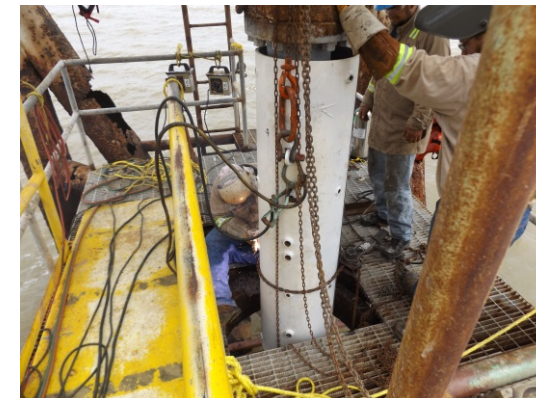
- Parted Conductor.
- Corroded / missing section surface casing.
- Production casing reinforced with carbon fiber.
- MADCON SCR Process Type 4 Bonded Sleeve Employed for Structural Repair

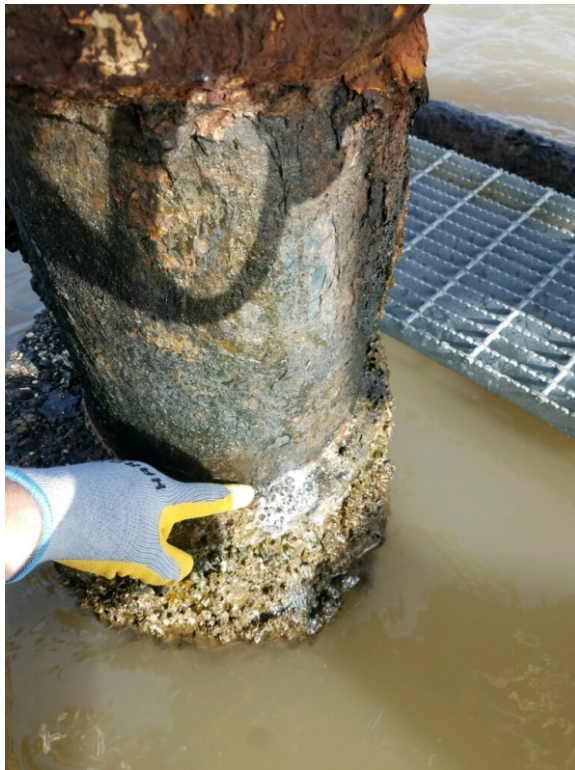
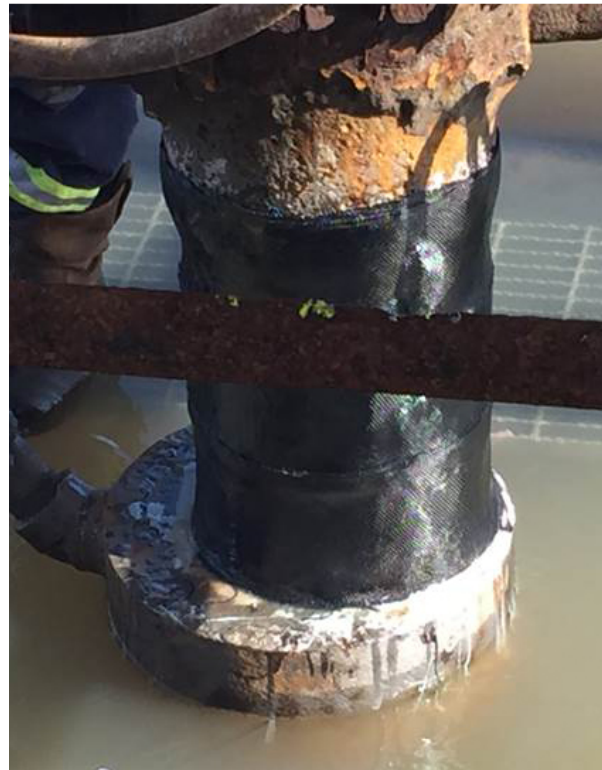
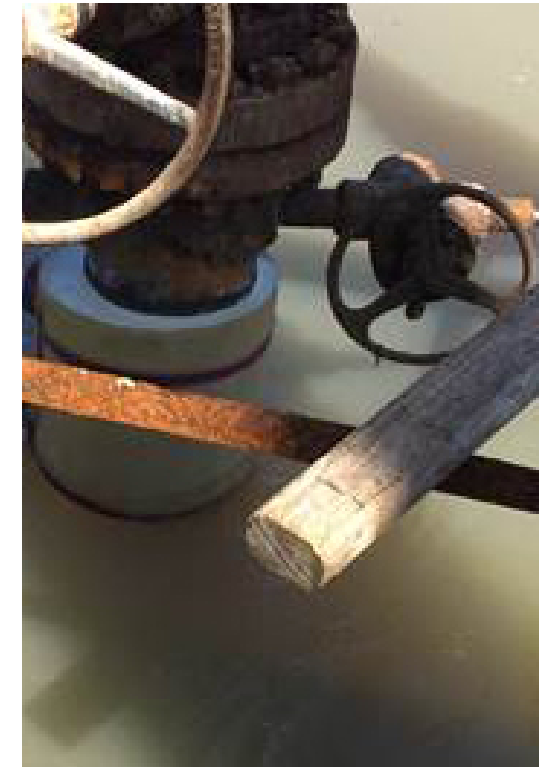
- Surface casing leaking.
- Installed carbon fiber to reinforce SC and stop leak.
- MADCON SCR Process Type 4 Bonded Sleeve

Employed for Structural Repair & Long-Term Corrosion Protection
