Well
Intervention Workshop
MED
20 September 2022

Preserving and Restoring Structural Integrity of Conductors & Well Casings

Bruce Trader
MADCON Corporation

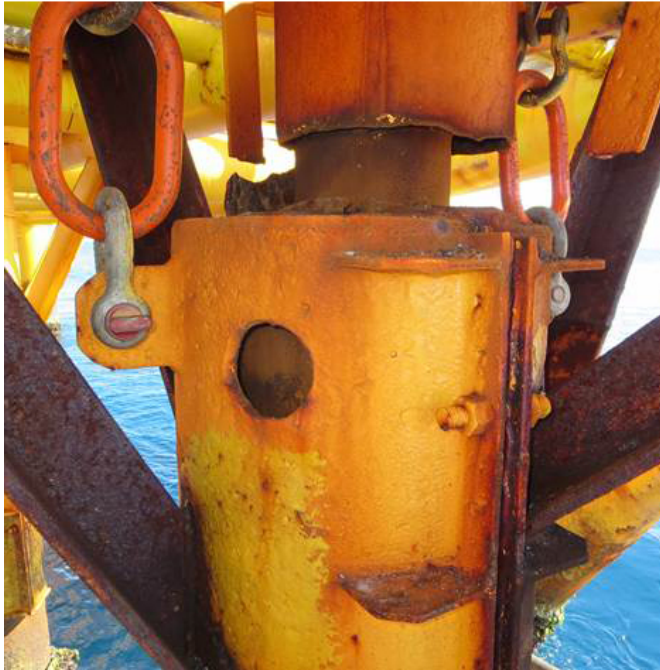
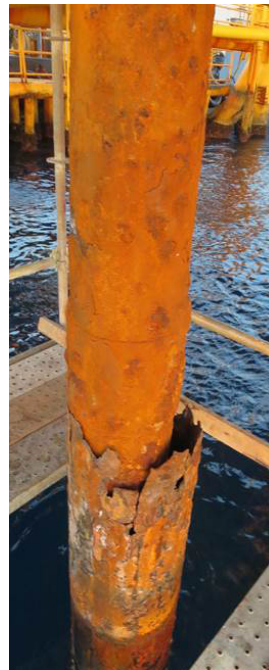
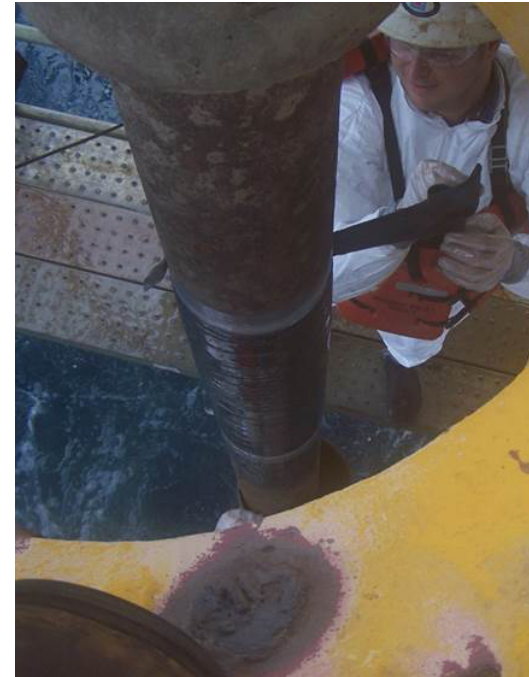
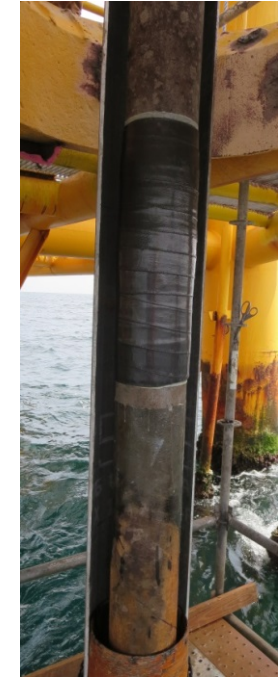
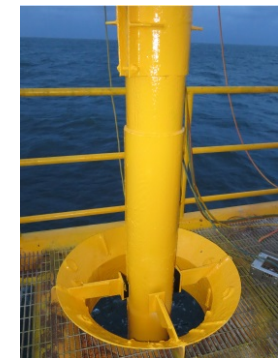
- Several costly, unsuccessful attempts to P & A.
- Removed multiple friction clamps that had been installed as prior repairs.
- Friction clamps create hot spot for service corrosion.
- Removed what was left of surface casing to access production casing.
- Multiple plies carbon fiber to reinforce production casing to hold 5,000 psi.
- MADCON SCR Process Type 4 Bonded Sleeve Employed for Structural Repair

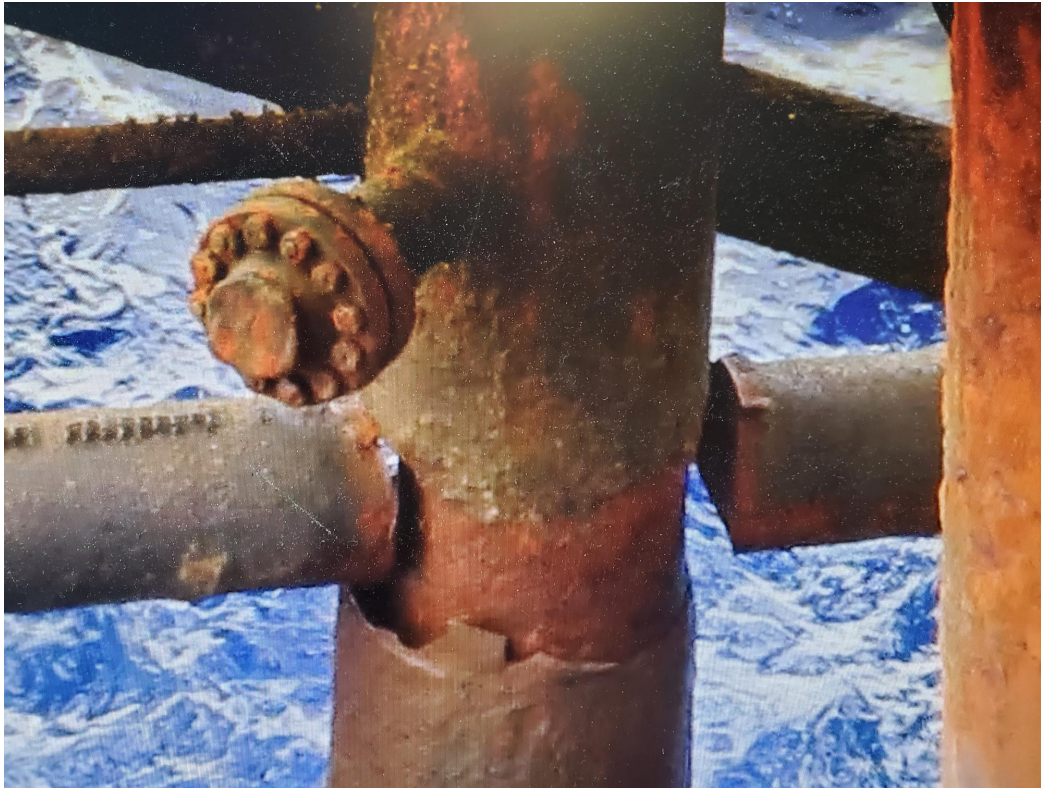
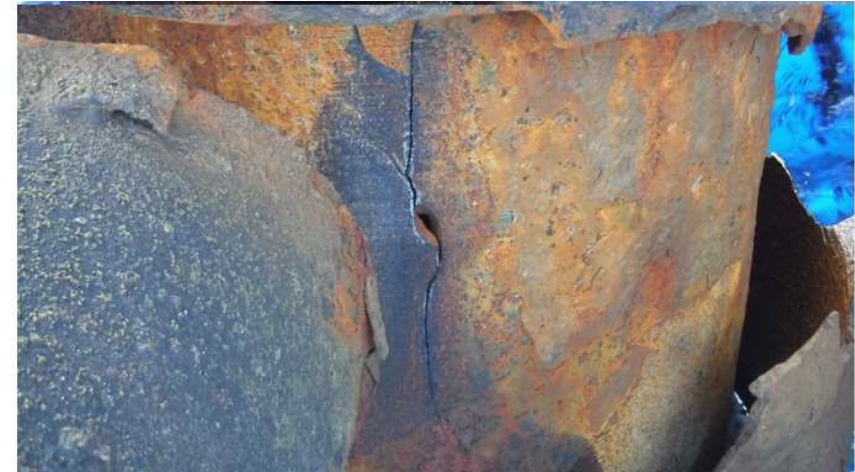
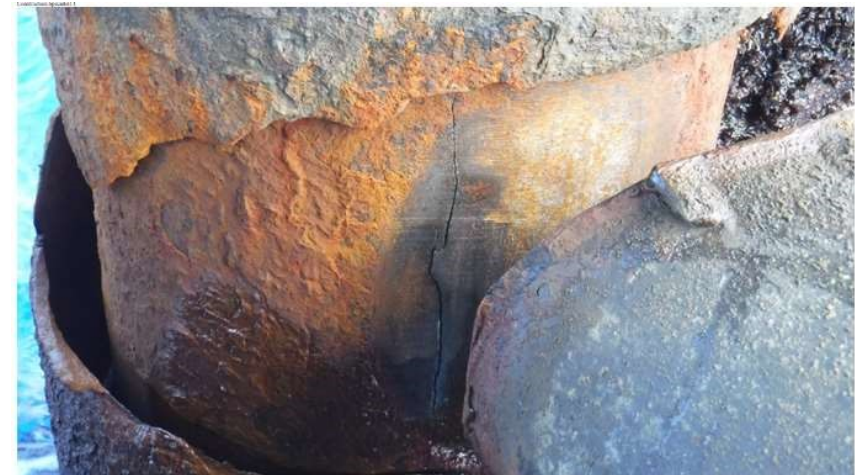
- 24" conductor corroded and separated
- Conductor guide corroded and missing
- Allowed conductor and 20 inch to bang around hitting horizontals
- Created cracks both sides of 20 inch

- MADCON SCR Process Type 4 Bonded Sleeve Employed for Structural Repair
- New conductor guide frame installed
