# CASE STUDY: THIS IS HOW WE DEALT WITH SUSTAINED CASING PRESSURE

Morten Evensen, Vice President, Wellcem

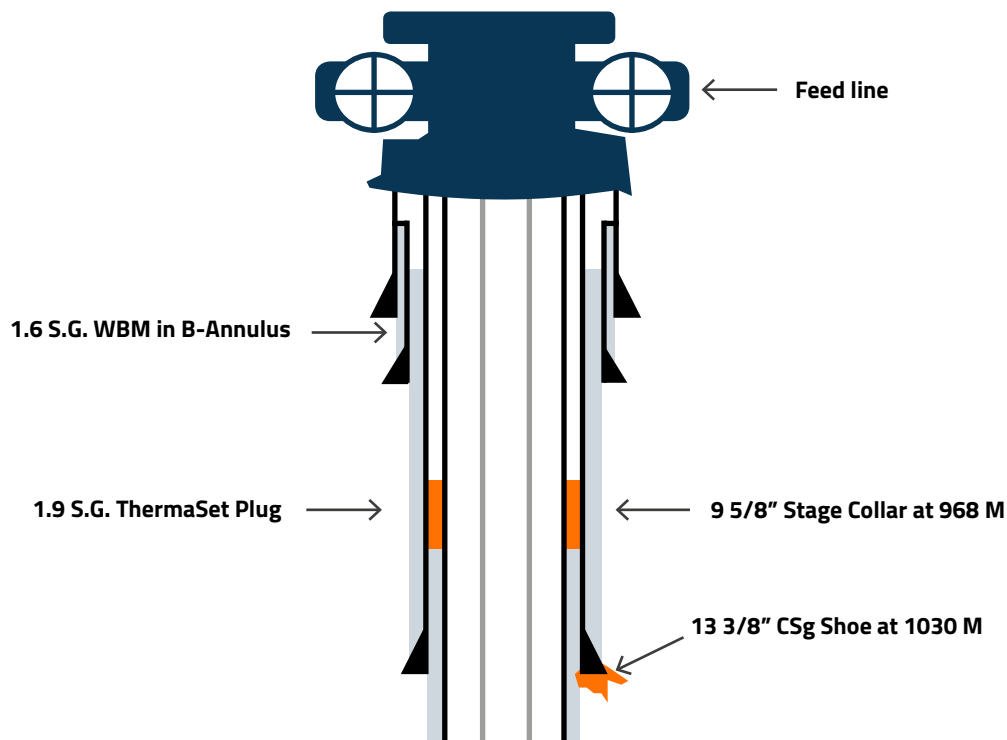
1. Prepare/mix 3 m3, 1,9 SG ThermaSet pill with 6 hours gel time at 50oC (temperature at the TOC). ThermaSet® was to be transferred to the batch mixer, the Micromax (weighing agent) mixed in, before the Curing Initiator was added to start the curing reaction.
2. Pump the pill into the B-Annulus with the help of centrifugal pump
3. The experimentally defined settling time of 1.9 SG ThermaSet® pill through 1.6 SG water-based fluid was approximately 2 hours.
4. Applied above 100 Bar squeeze pressure to squeeze maximum volume of the pill into the channel. As per job program, the surface squeeze pressure was kept ~ 100Bar till curing of the pill (>12 hours).
